C&F LAND RESOURCE CONSULTANTS LTD.

Re: Agricultural Benefit Provided by Rehabilitation of Debilitated Site at Millennium Greenhouse, 3752 Arthur Drive, Delta, B.C.

MILLENNIUM GREENHOUSE SOIL REHABILITATION - 2016

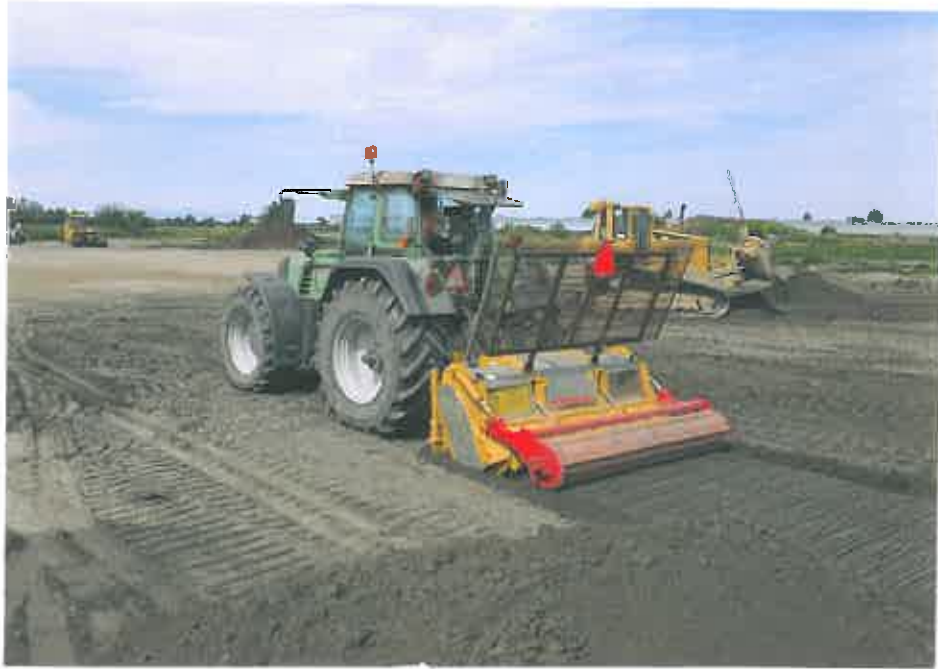
Seppi soil renovator in action

cultivable, stone free soil at least 0.9 metres thick. The imported soil was laid down in lifts no greater than 0.3m and then treated with a lifting shank cultivator to bring larger stones to the surface where they were removed with a bobcat loader equipped with a screened bucket. The rocks were piled and later removed from the site. After the cultivator treatment, the site was subjected to grinding with a two passes with a Seppi renovator which grinds any stones to a gravel size or less. When the grinding was completed on the first lift, two more lifts were successively brought in and subjected to the same treatment as the first lift. The site was finish graded level with a gentle slope from west to east. A cover crop was seeded by a local farmer to provide protection over winter. Some re-grading may be required in the spring to address minor settlement and ponding issues.

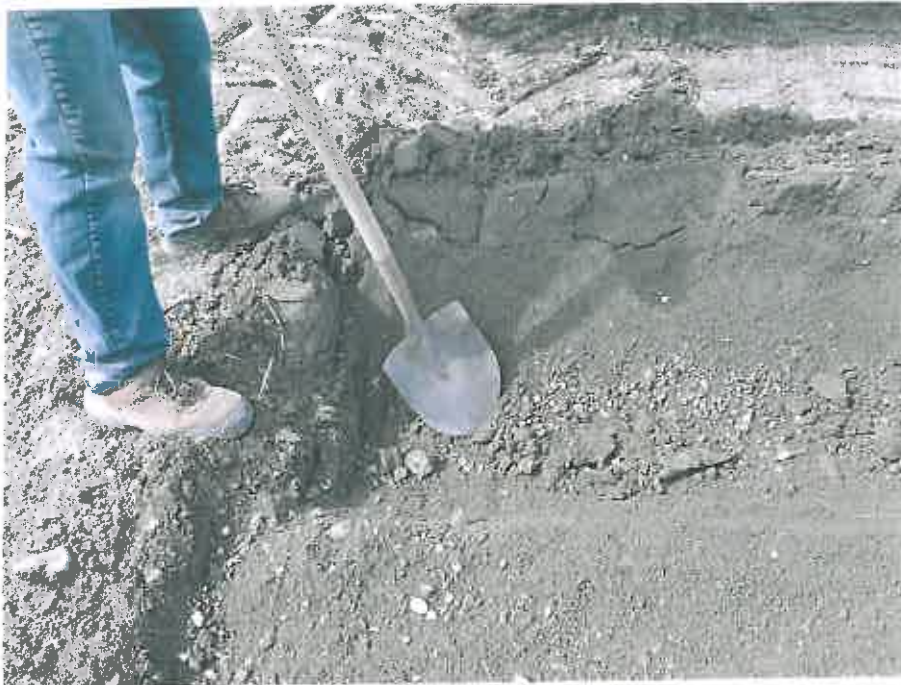
Soil condition after one pass of Seppi soil renovator, stones gone

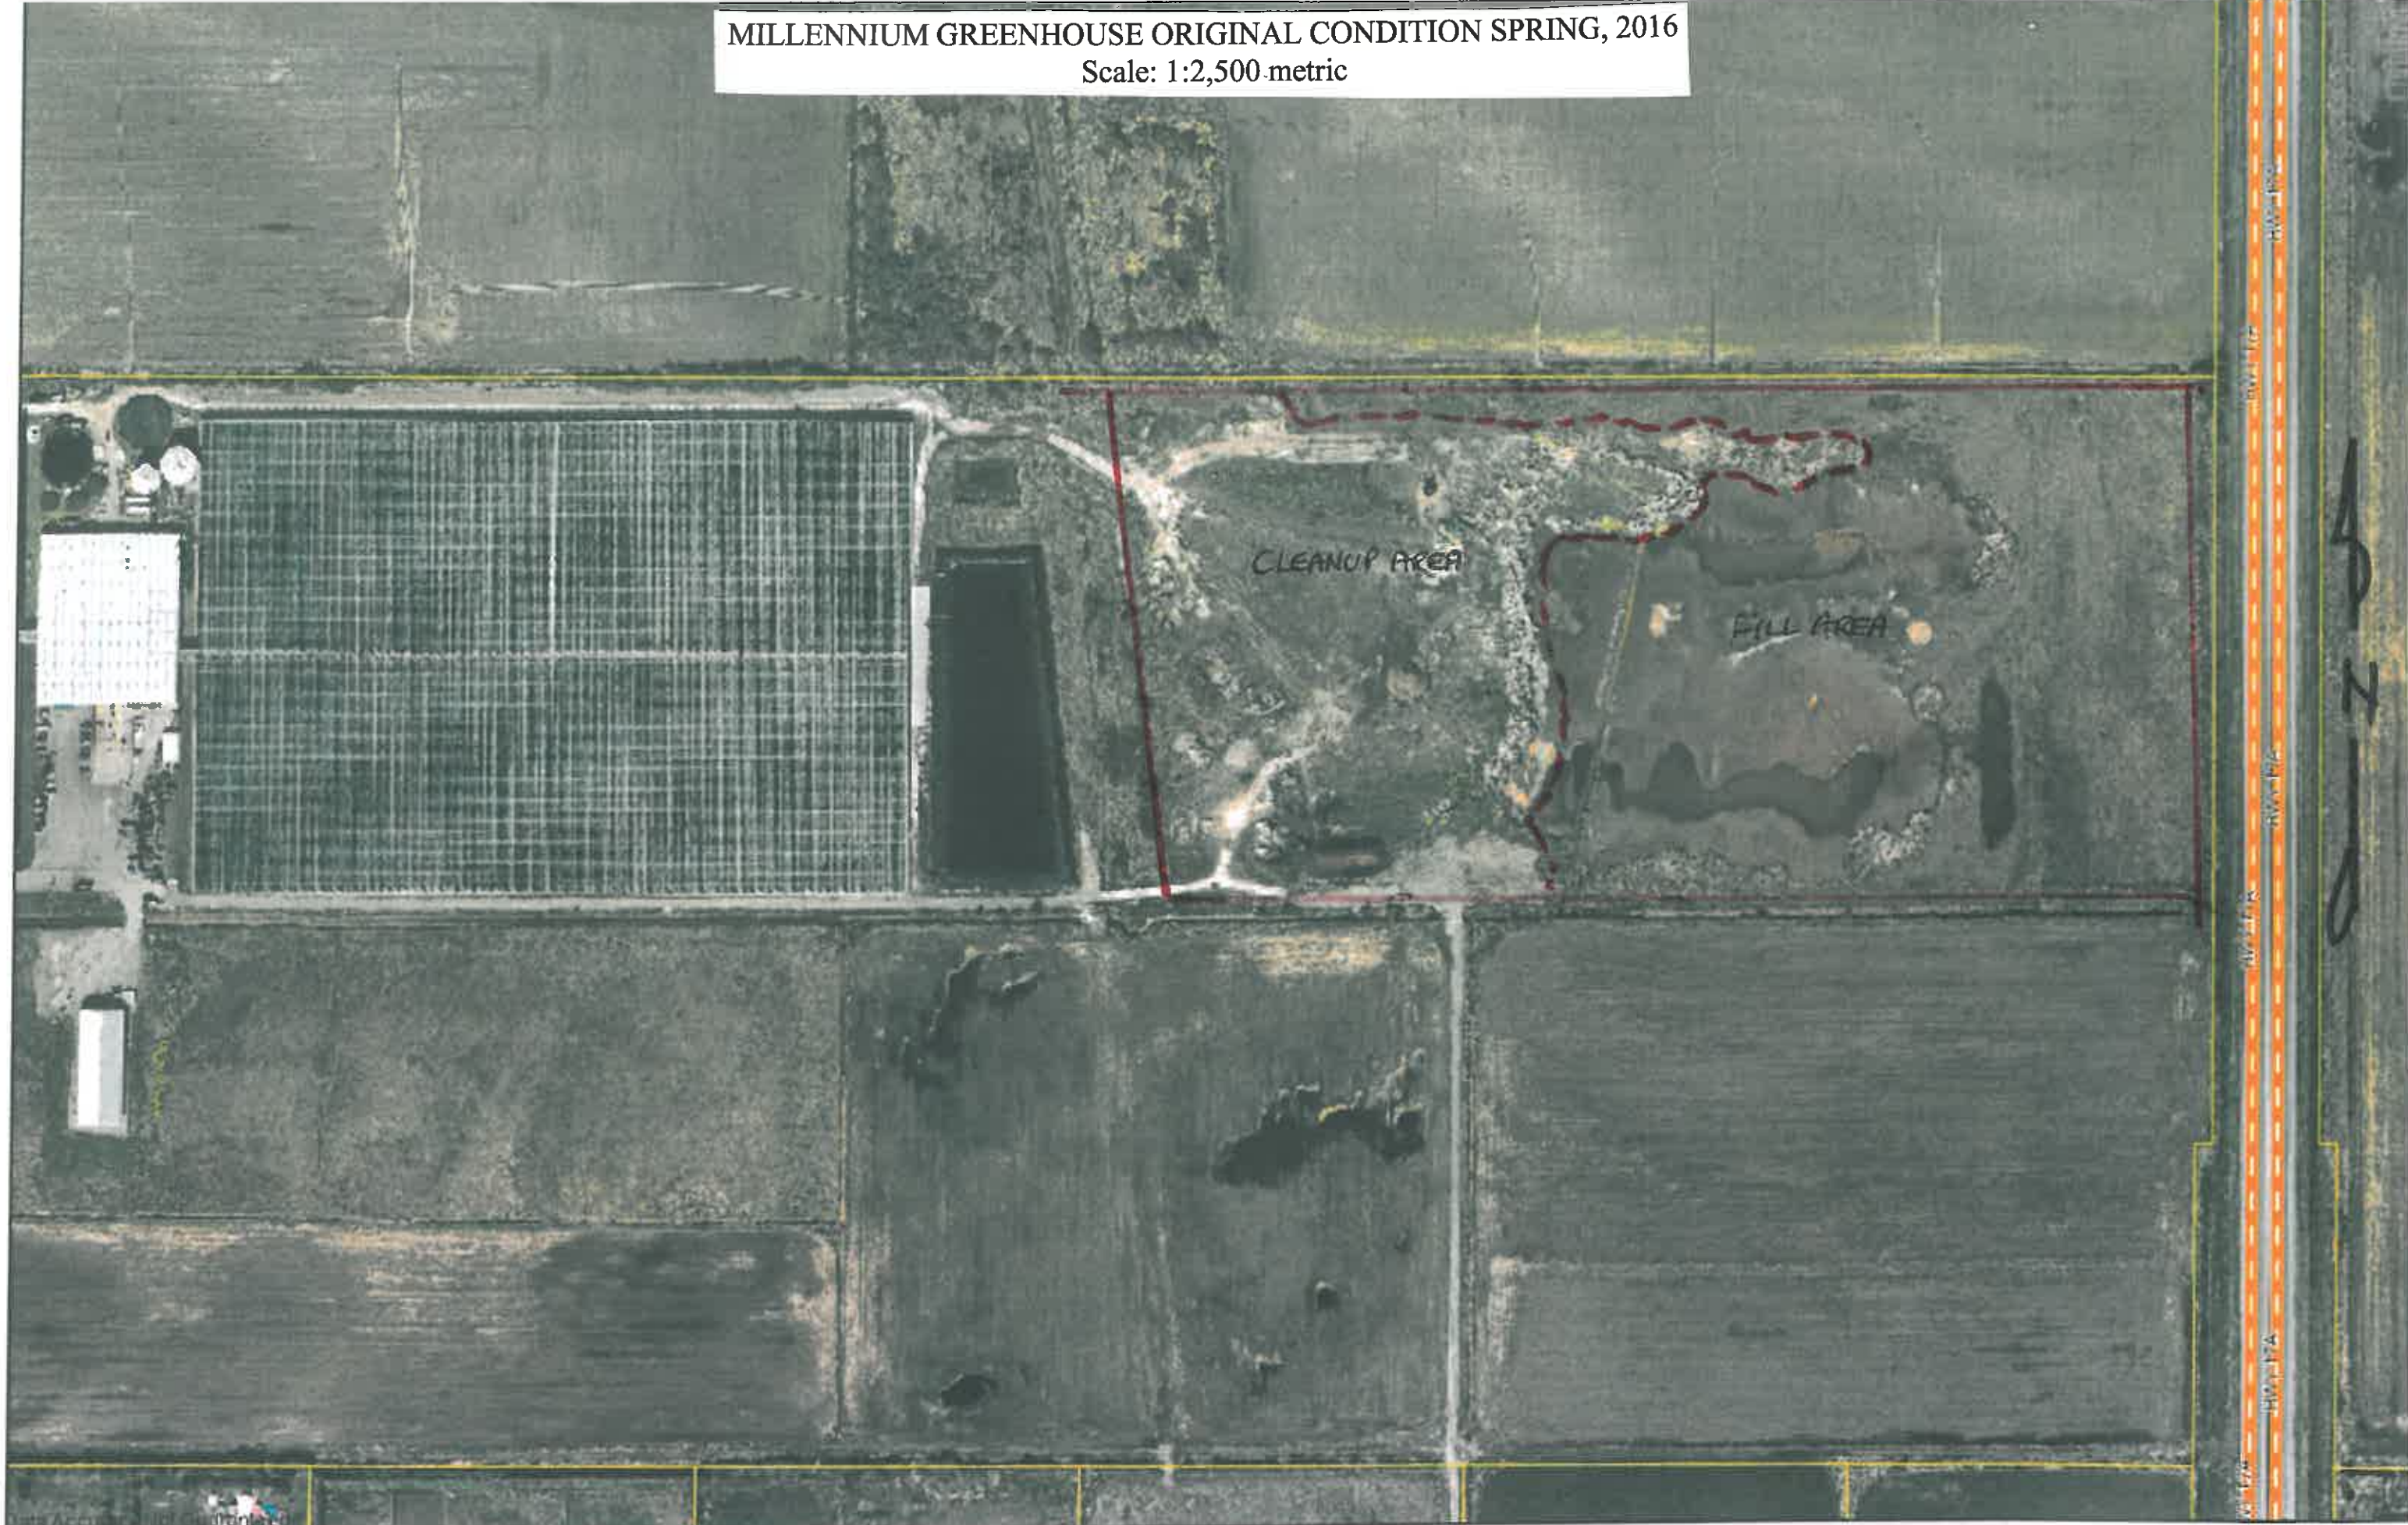
MILLENNIUM GREENHOUSE ORIGINAL CONDITION SPRING, 2016
Scale: 1:2,500-metric

Two aerial photographs of the site area attached hereto showing the former and rehabilitated site. The depressional area and area with debris are shown on the former photograph. The depressional area covered 5.8 hectares and the debris area covered 4.2 hectares. The final condition photograph taken on December 7, 2016 shows the filled area of 6.15 hectares and the leveled former debris area of 3.85 hectares. In total, 10.0 hectares were rehabilitated. Photographs of the soil rehabilitation process are attached hereto.

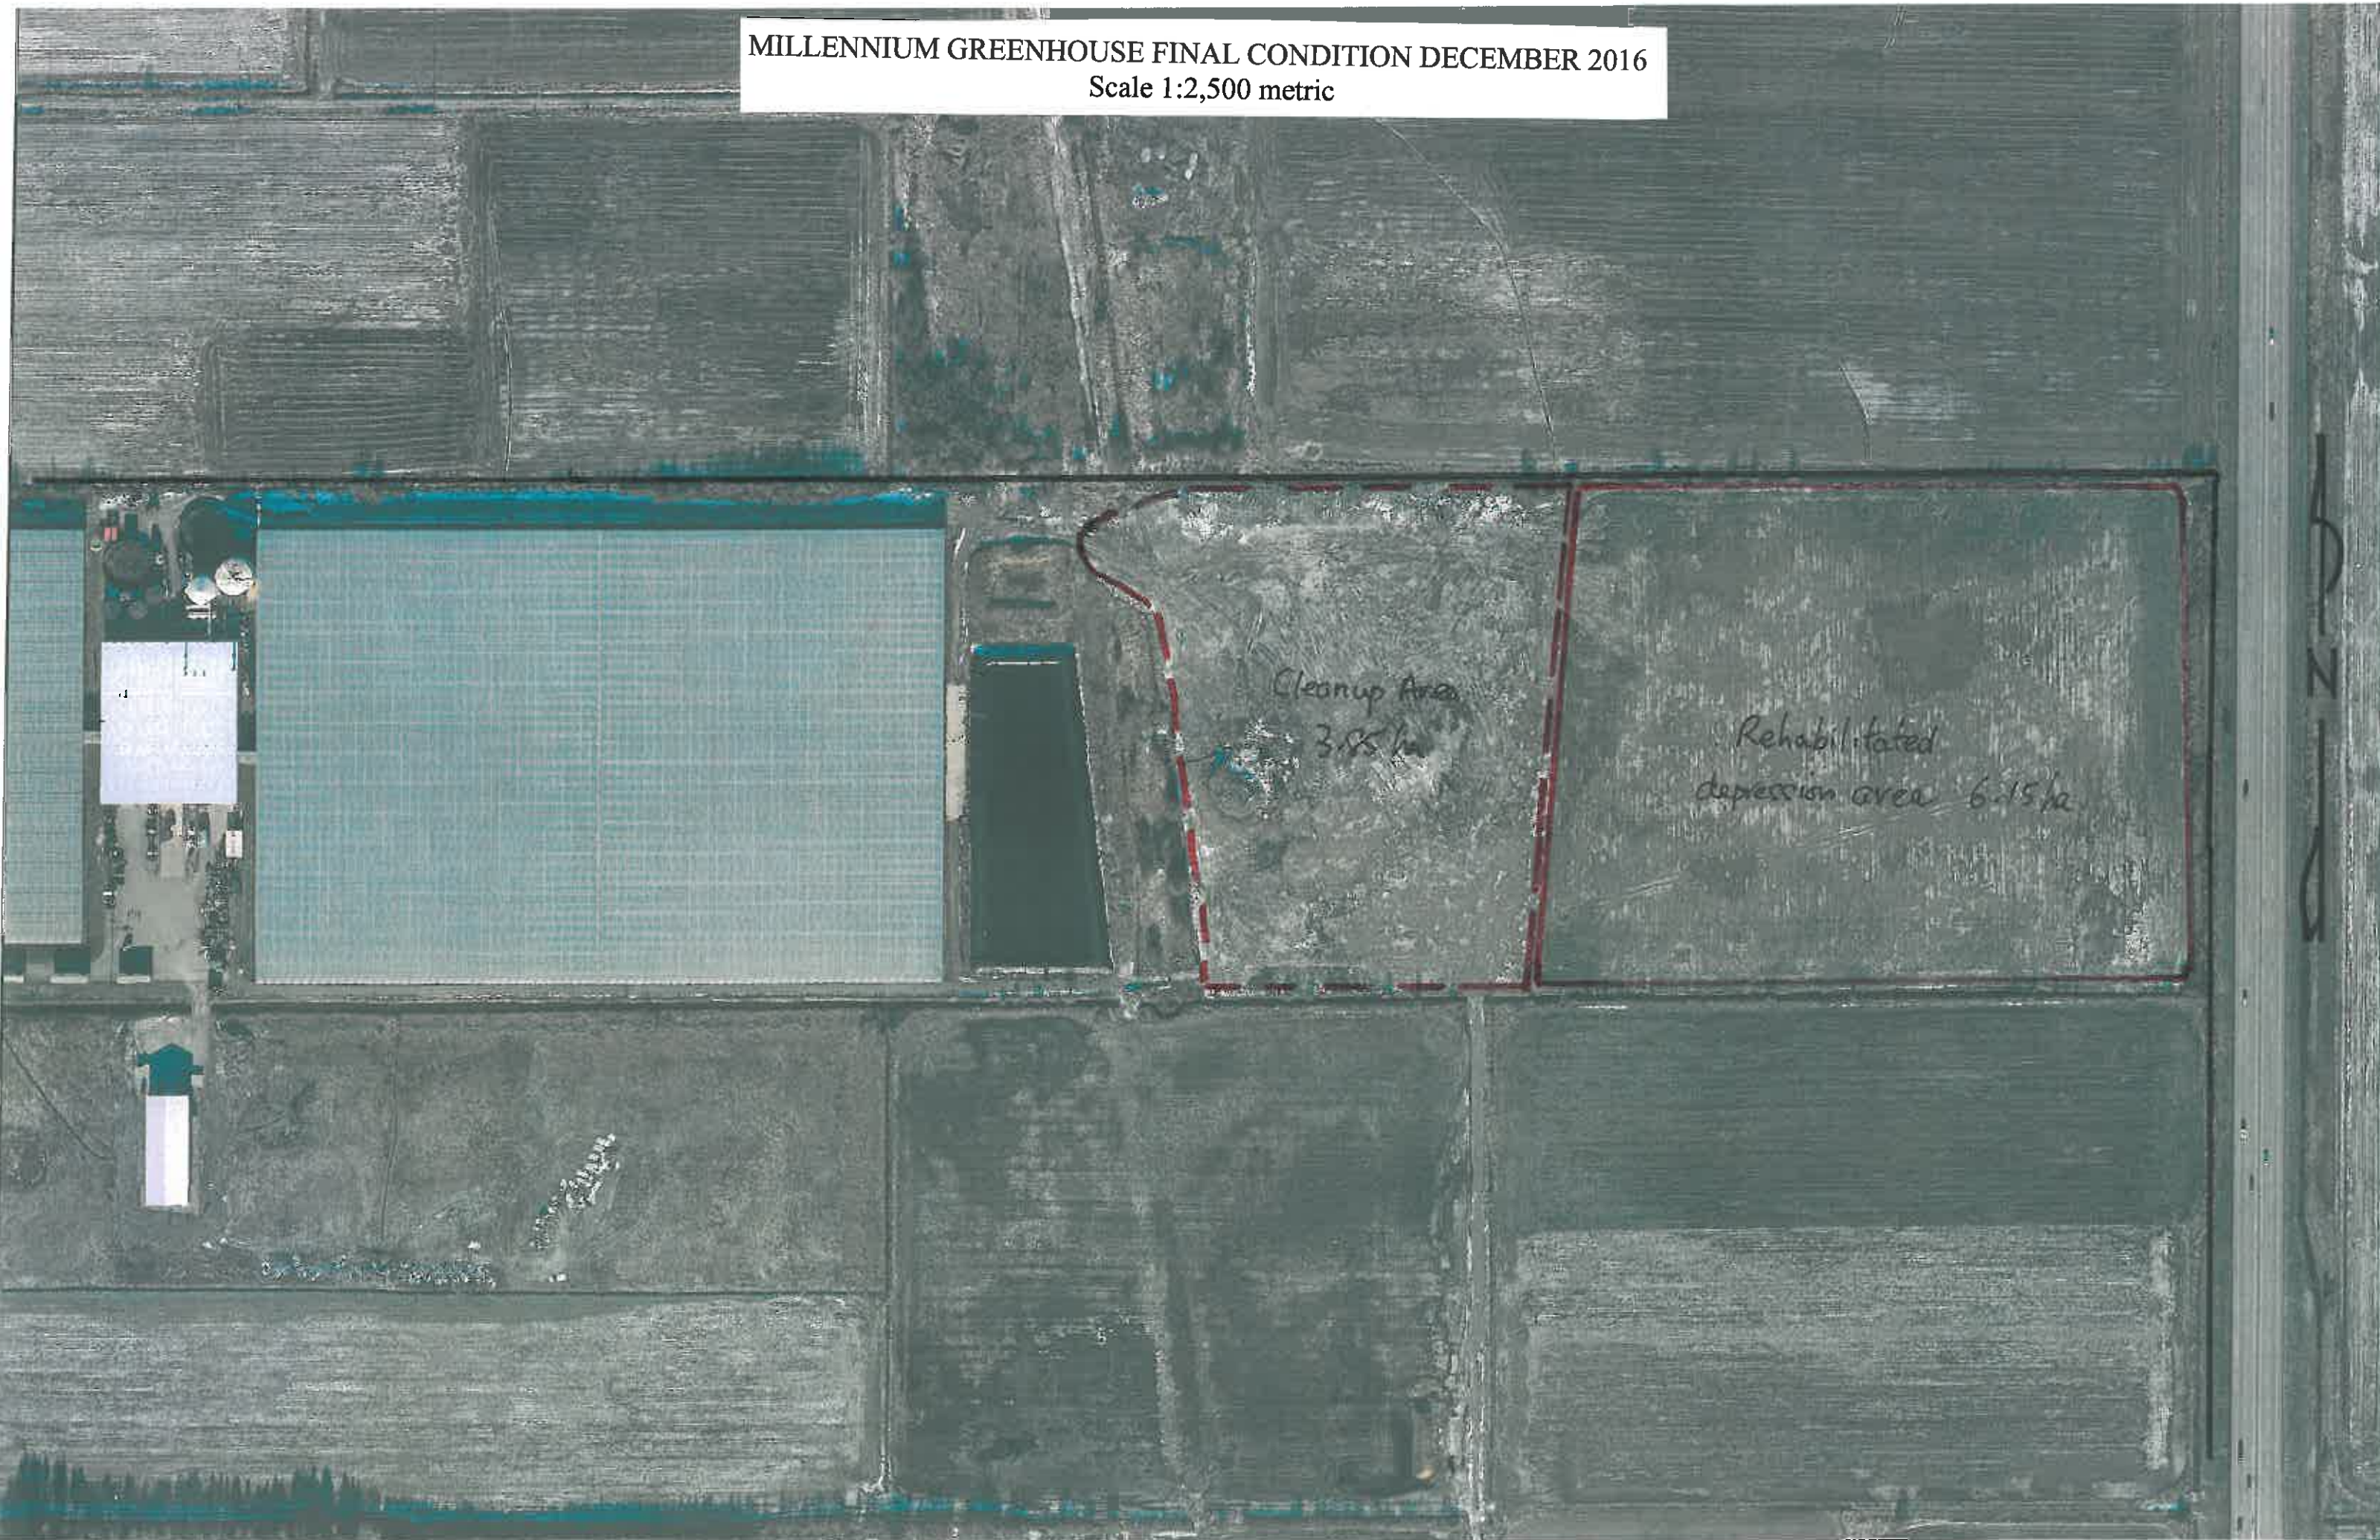
MILLENNIUM GREENHOUSE FINAL CONDITION DECEMBER 2016
Scale 1:2,500 metric

Cleanup Area
3.85 ha

Rehabilitated
depression area 6.15 ha
